**RE: SRN / ID: U821810662, Wayne County
1491 W. Jefferson, Trenton MI 48183 (the "Site")**

This letter is a response to the November 25, 2019 Notice of Violation (NOV) and is intended as the written response of Next Generation Environmental, Inc. (NextGen) and MSC Land Company, LLC (MSC).

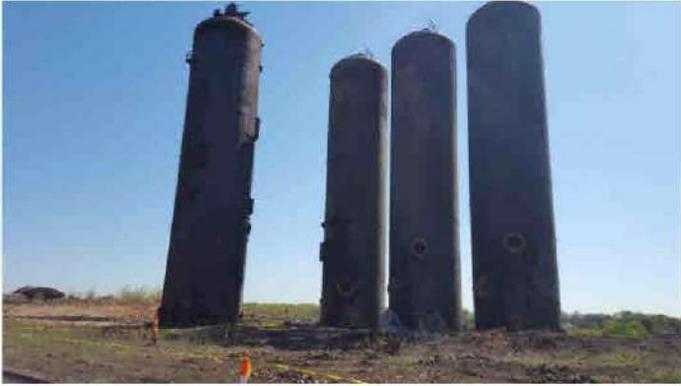
McLouth Stoves

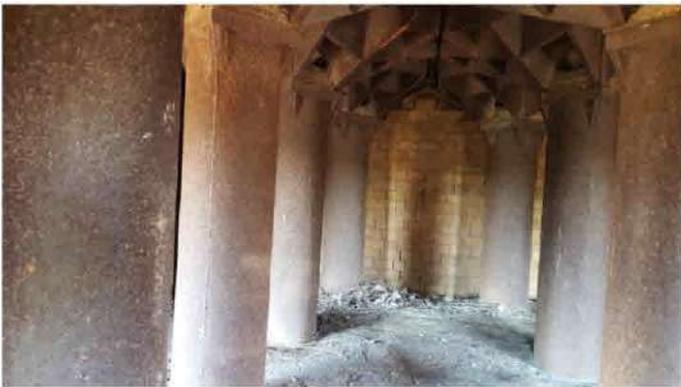
Stoves Interior Piping

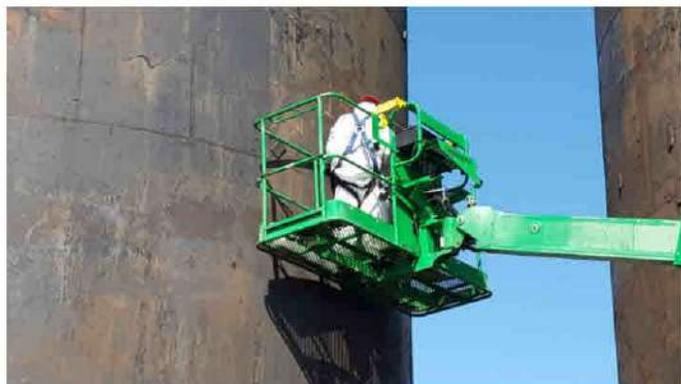
Sampling and showing weld joints

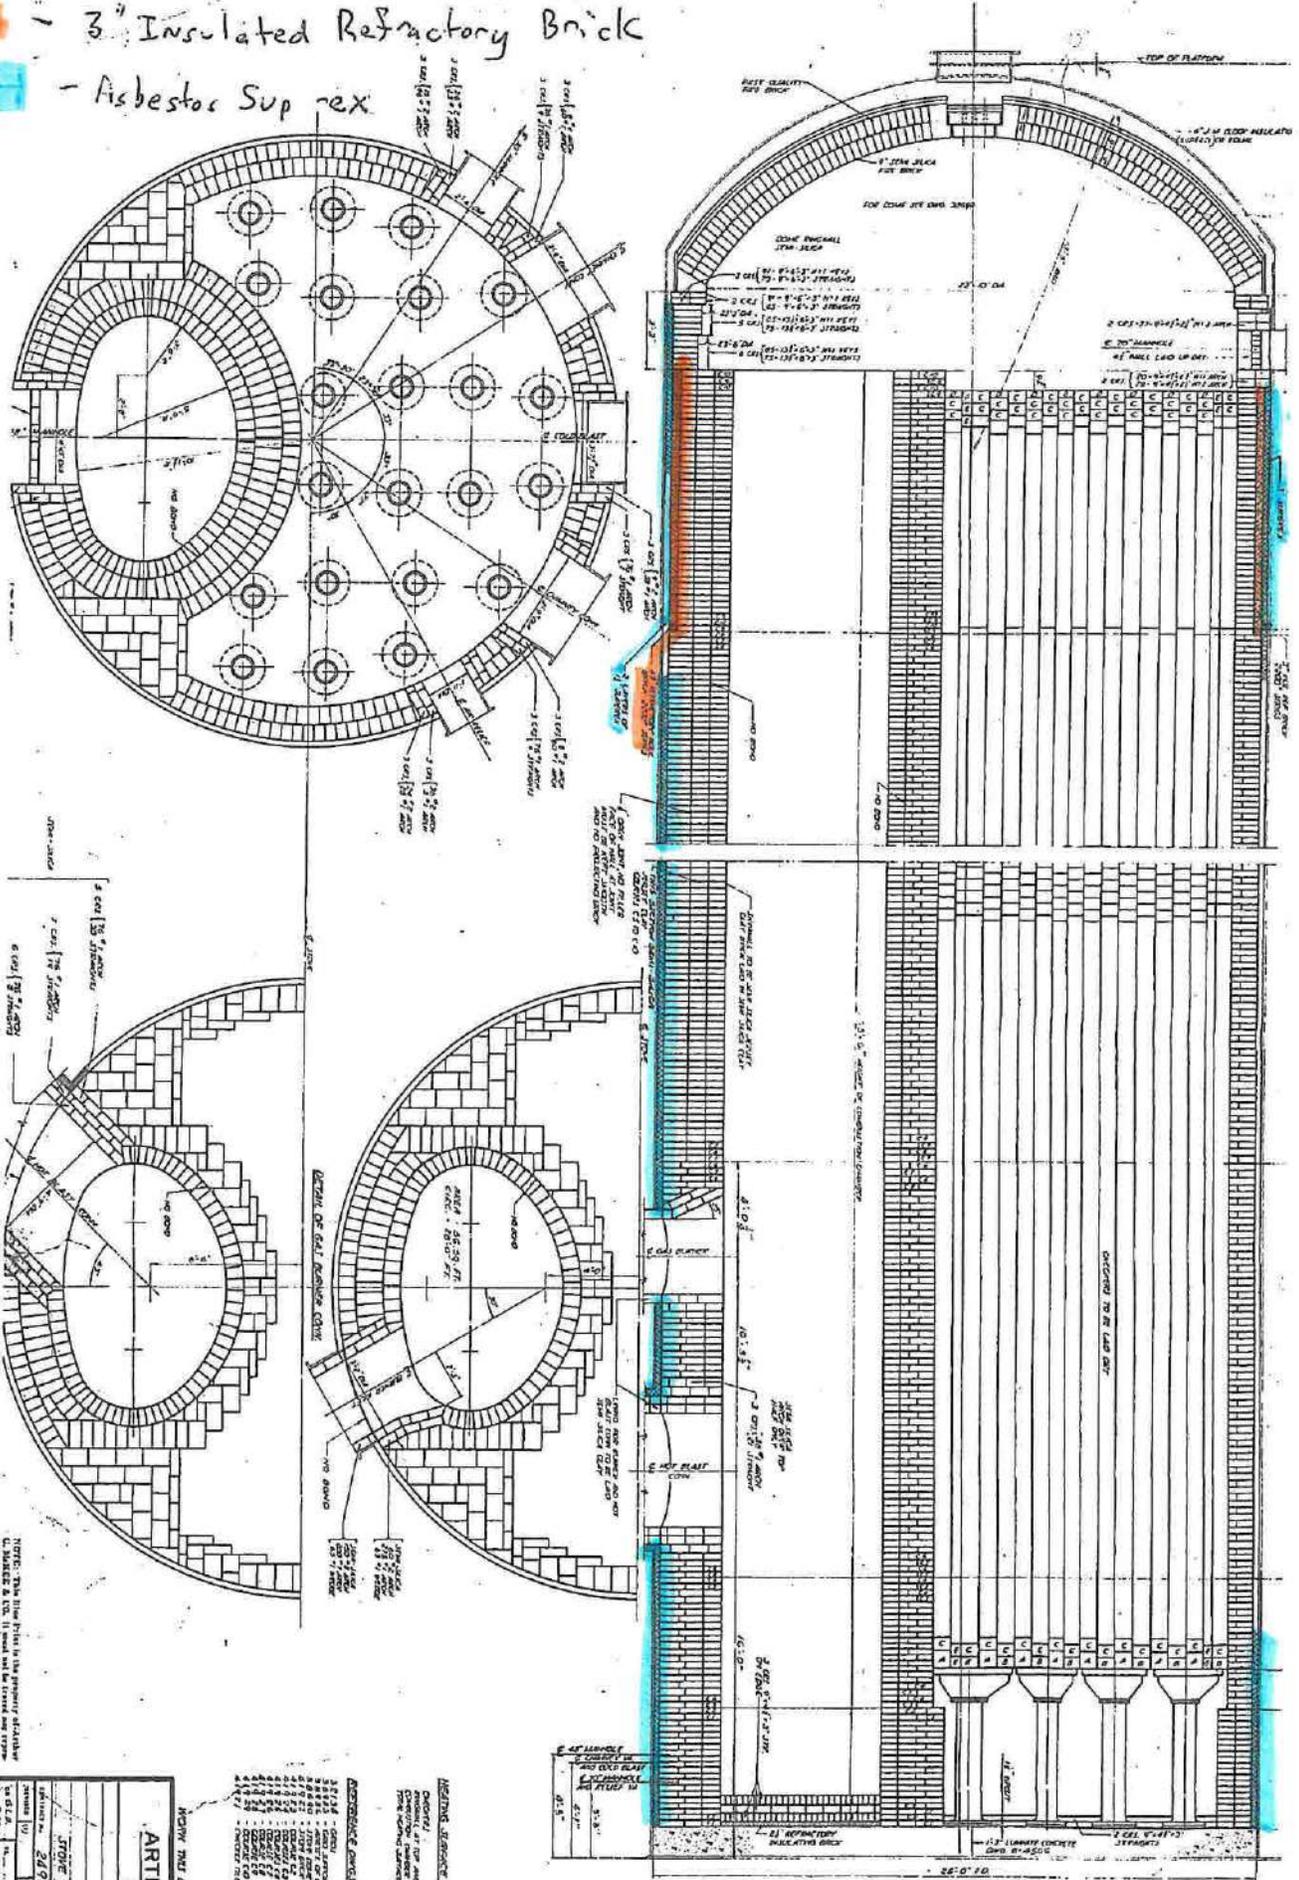
Complete Stove Schematic

3" Insulated Refractory Brick
 - Asbestos Sup rex

In limited areas of the interior steel rings there is Suprex insulation (asbestos containing material with between 15-30%) and a series of dry stacked fire brick layers. The majority of the bricks have been found to be negative for asbestos (see Appendices B and D). There is a limited quantity of refractory brick in the upper level of the stove that could not be accessed for sampling. Based on age of construction, it is reasonable to assume that this upper refractory brick may contain asbestos. On the diagram in Appendix B, the Suprex asbestos insulation is highlighted in blue and the assumed positive refractory brick is highlighted in orange.

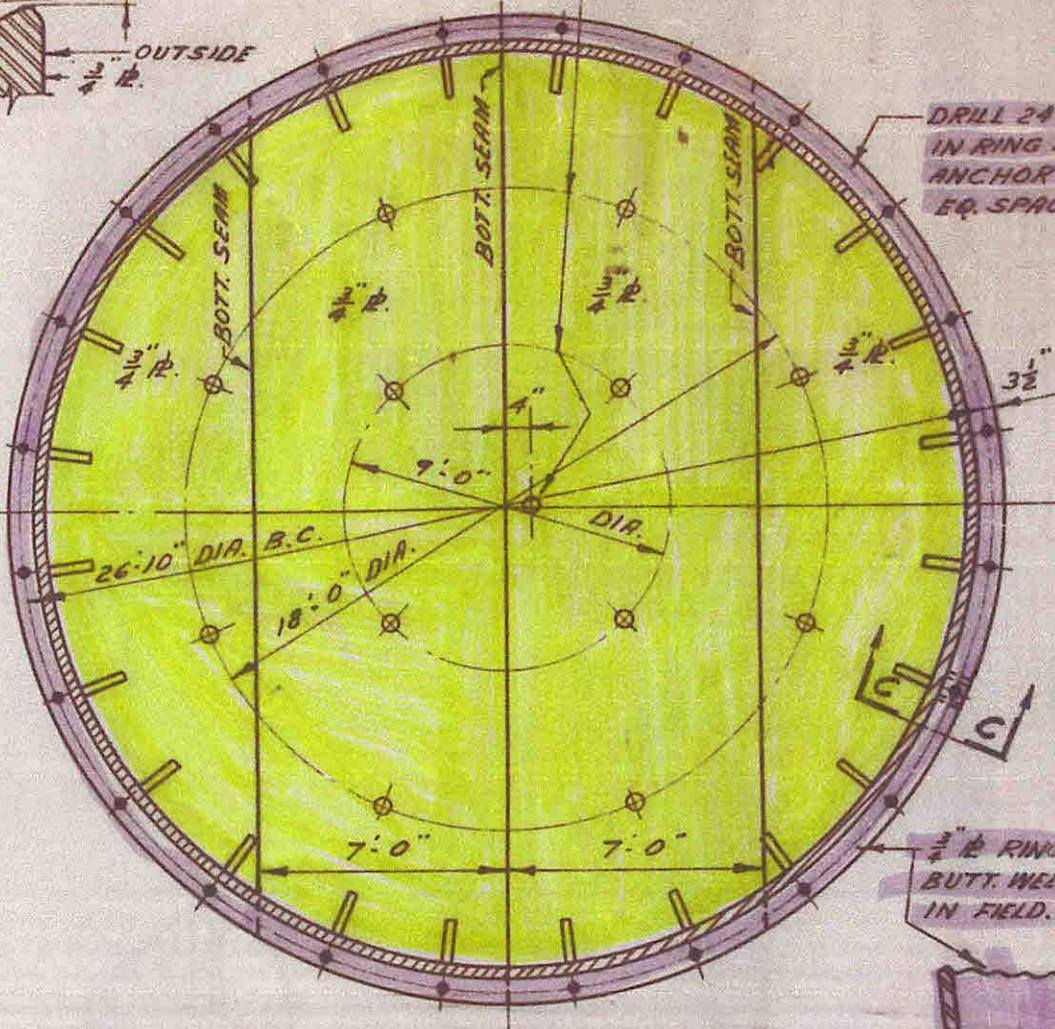
STOVE BOTTOM PLATE

Stove Schematic Showing Base Plate Configuration

WELD IN 13-2" HALF COUPLINGS IN BOTTOM { FOR CONT. 2719 ONLY }
 TAP 13 HOLES FOR 2" STD. PIPE PLUGS { FOR CONT. 2490 ONLY }

DRILL 24-3/4" Ø HOLES IN RING FOR 3" ANCHOR BOLTS EQ. SPACED.

3/4" RING BUTT WELD IN FIELD.

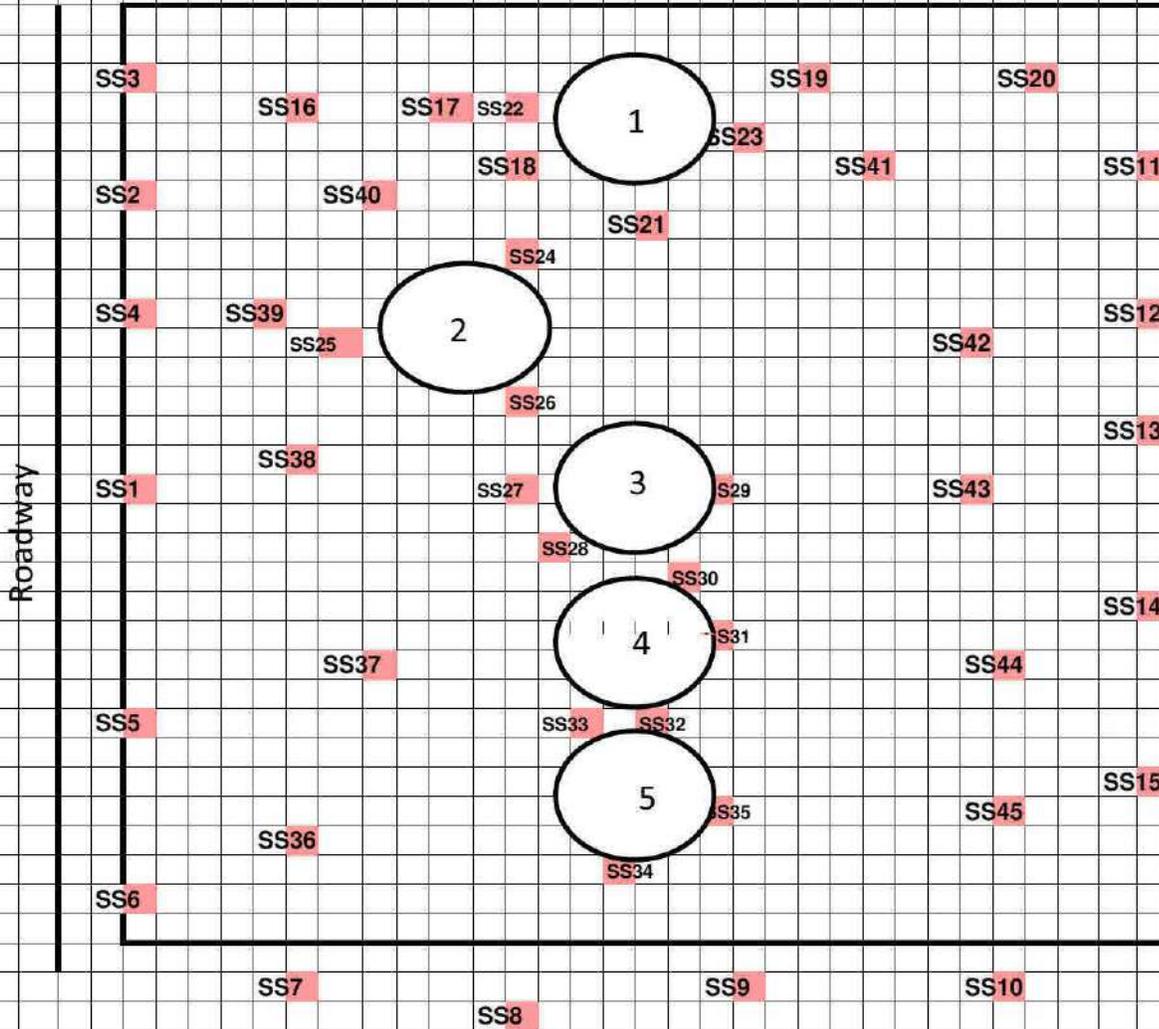
Each square on grid represents roughly an 8' by 7' area.

"SS#" represents the soil sample taken from that location.

2. To this end, ETC plotted a random soil sampling scheme and acquired soil samples from throughout the subject stove removal area (see Appendix E). Of the 45 samples taken, 20 of these samples were found to have asbestos contamination (trace quantity or higher). While the majority of these samples were in the area of the previous demolitions, the random sampling scheme and large percentage of positive samples would require that all of the existing surface area be considered previously contaminated.

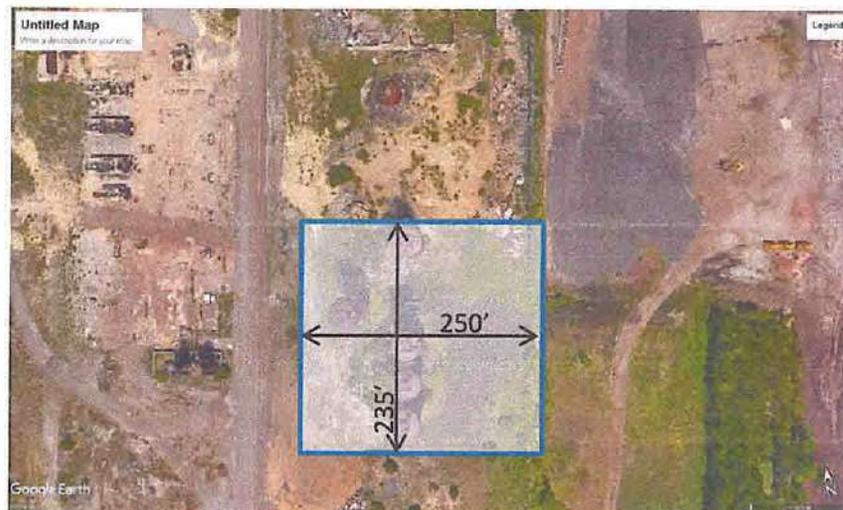
1. Management of demolition water during lay down of stoves
 - a. Primary water management controls: Lay down area
 - i. Area immediately around the stoves will be cleared of debris.
 1. Lay down area will be approximately 250' x 235'
 - ii. Millings will be laid and compacted
 - iii. Lay down area schematic

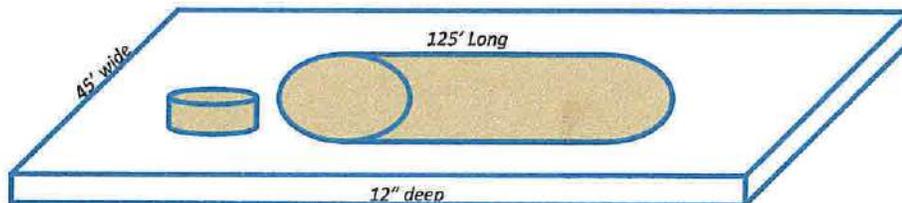
- iv. Lay down pad schematic
- b. Secondary water management controls: Stove lay down pads
 - i. Berms will installed around the perimeter of the stove lay down pad
 - ii. Poly will line the interior of the lay down area
 - iii. 12" of millings or other material will be placed in the stove lay down pad over the poly
 - iv. Lay down pad schematic

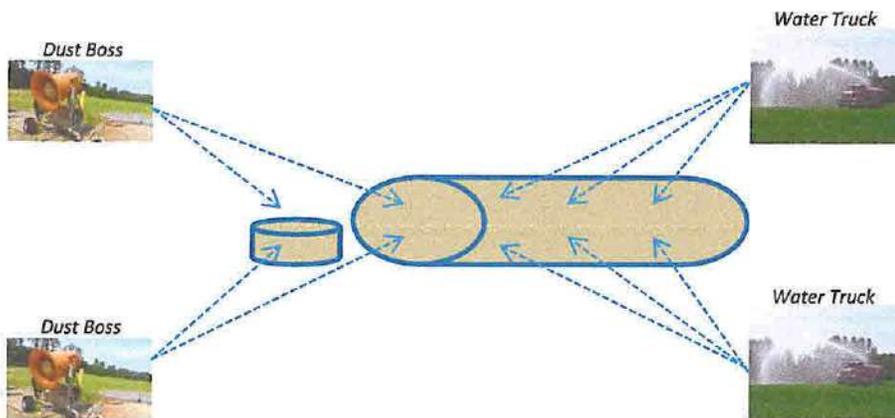
- c. Standard operating procedure during stove lay down process
- i. Only authorized personnel will be permitted on site during lay down operations.
 - ii. Work area will be demarcated with asbestos ribbon and signs
 - iii. Lay down pad will be pre-wetted but not over saturated
 - iv. Two Dust Bosses will be positioned opposite the direction the stoves will be laid down.
 - v. Dust Bosses will have a consistent spray of water into the “mouth” of the stoves during the lay down process.
 - vi. Water trucks will be positioned laterally, on either side of the stoves in the event of a breach of the stove
 - vii. A competent person will make the call when watering shall cease.
 - viii. Mouth of stove will be sealed with 6 mil plastic.
 - ix. Watering Schematic

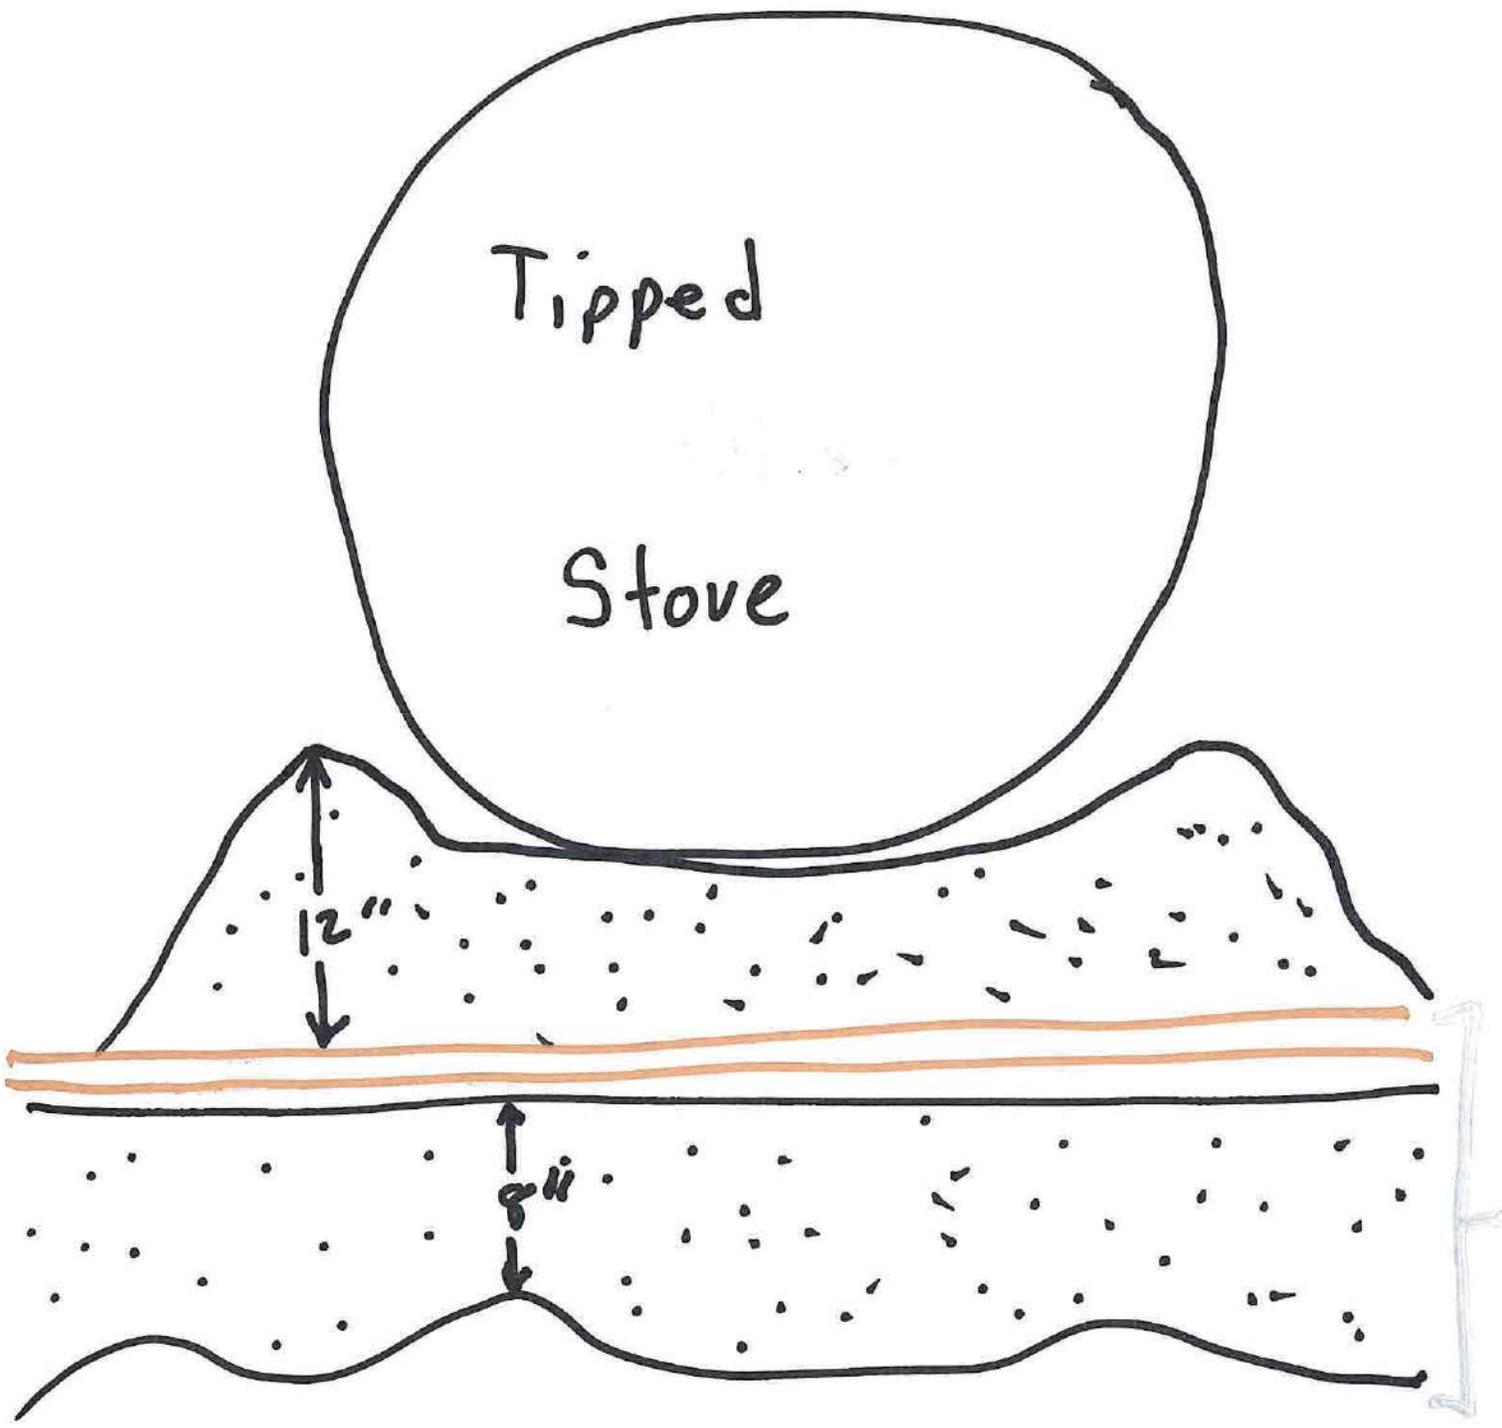
Cross section of Existing Surface,
New Millings layer
and Millings Berm

previously contaminated layers

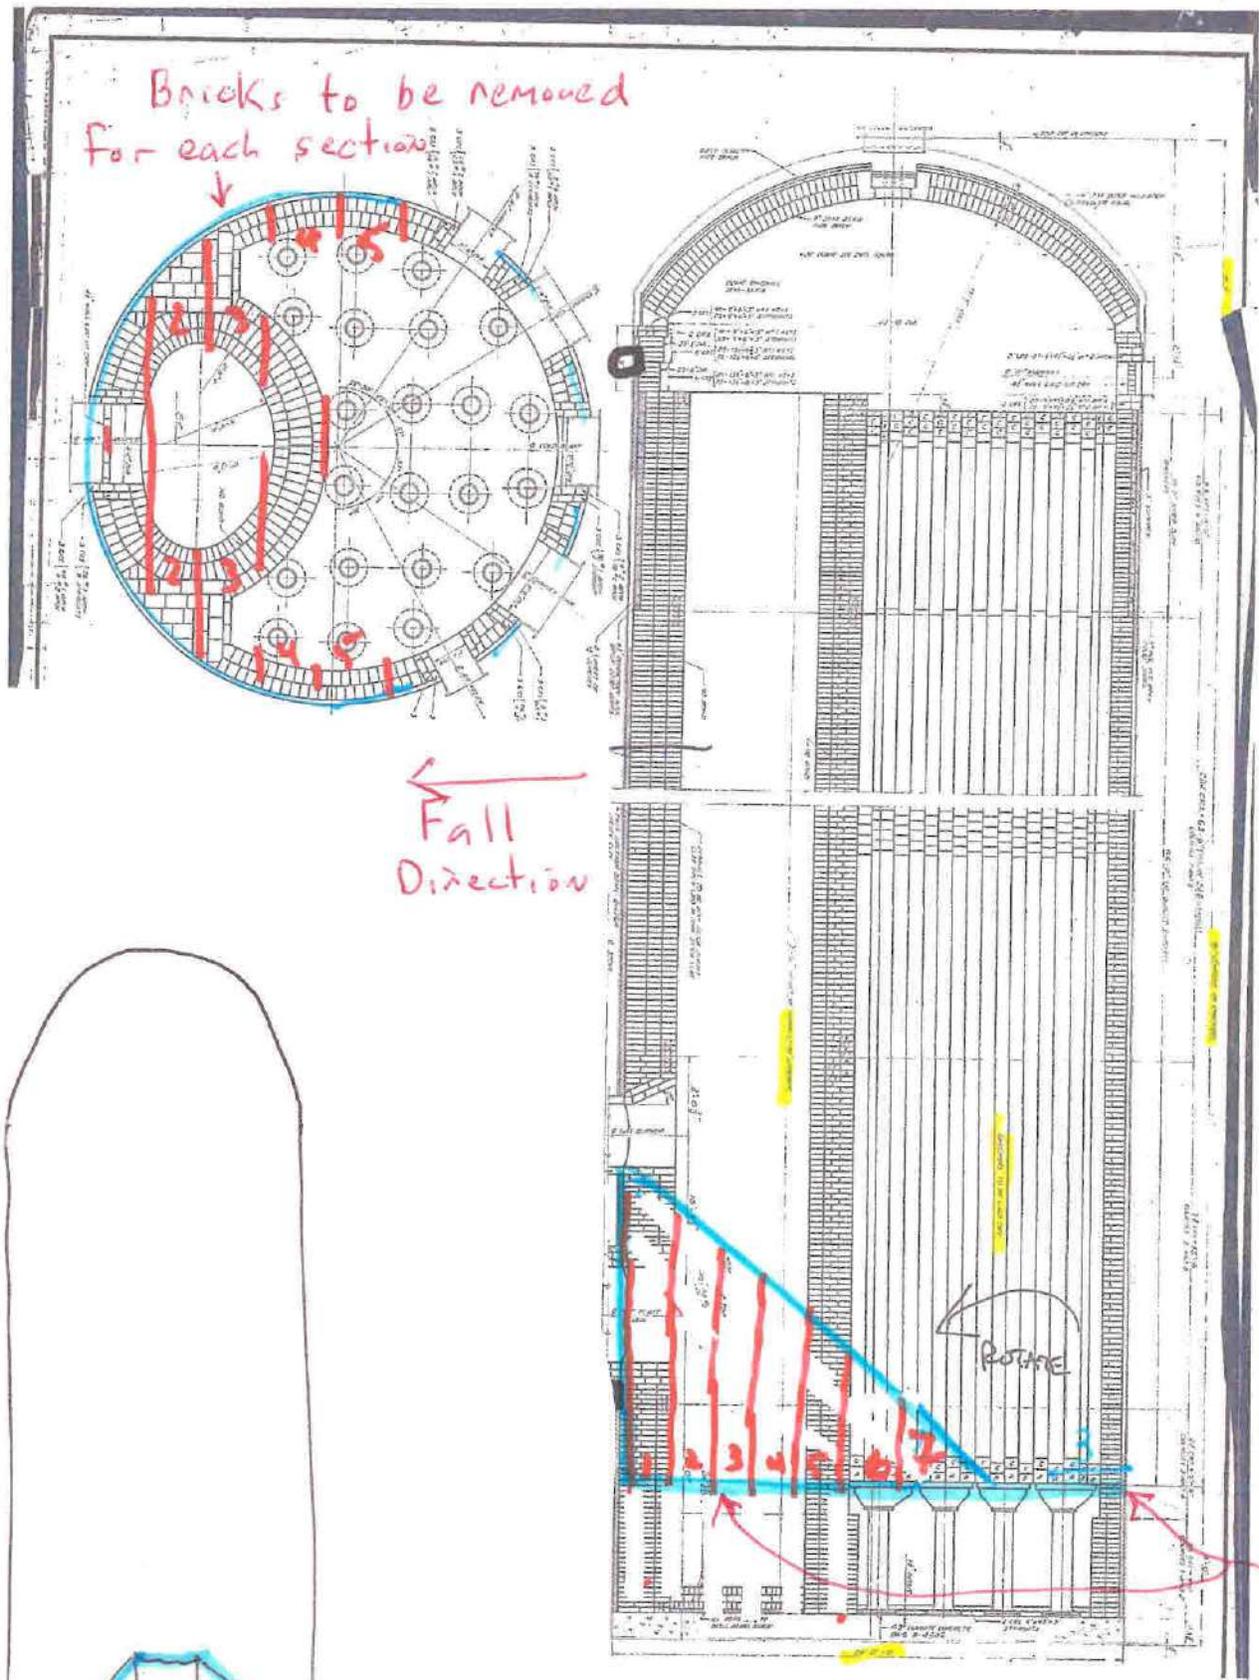
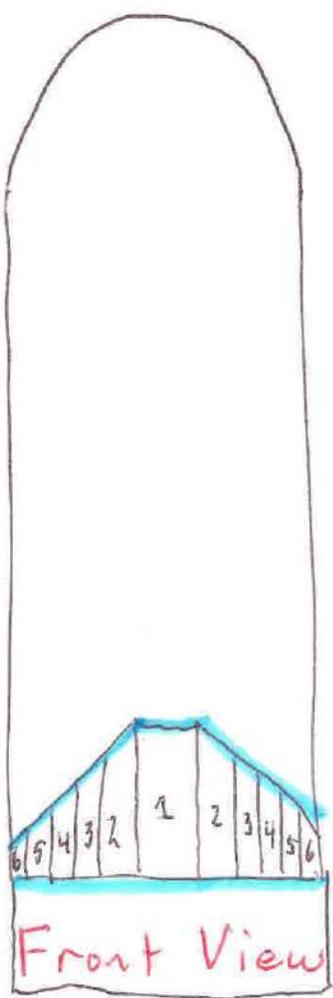
Appendix H
Wedge Cut Diagram

Side View

Water Jet Cuts

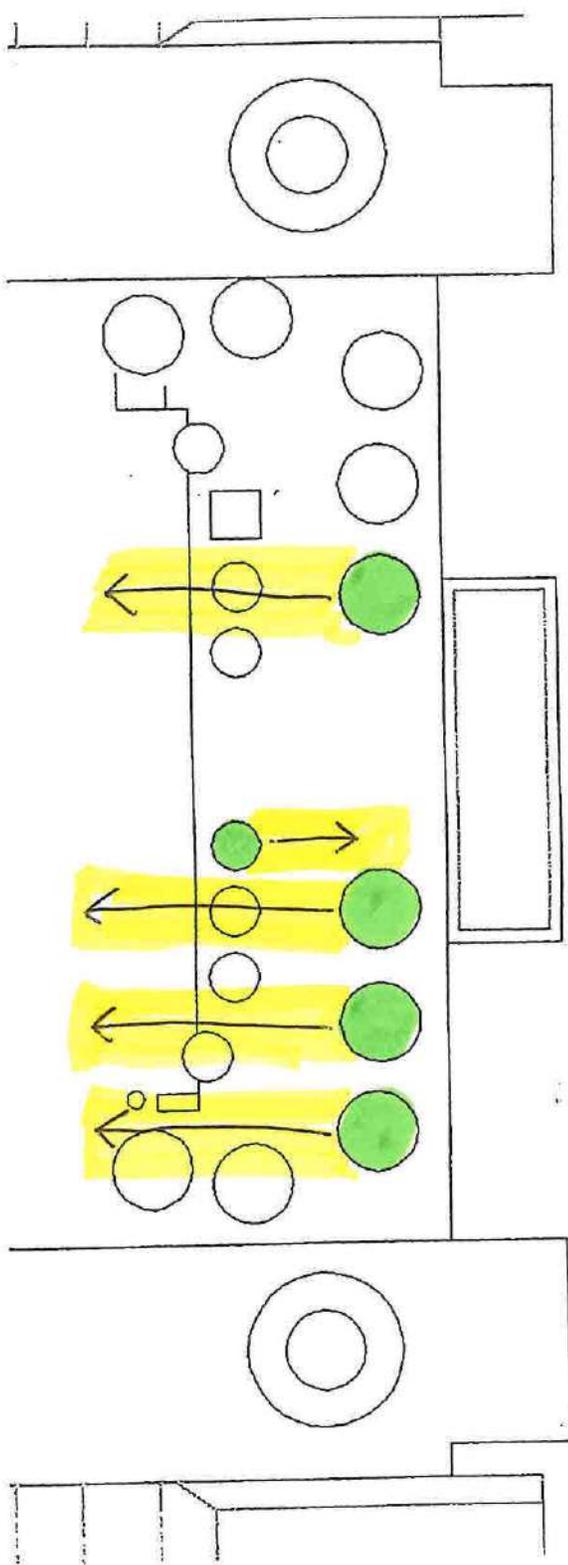
Trestle

● - Stoves

■ - Tipping Direction

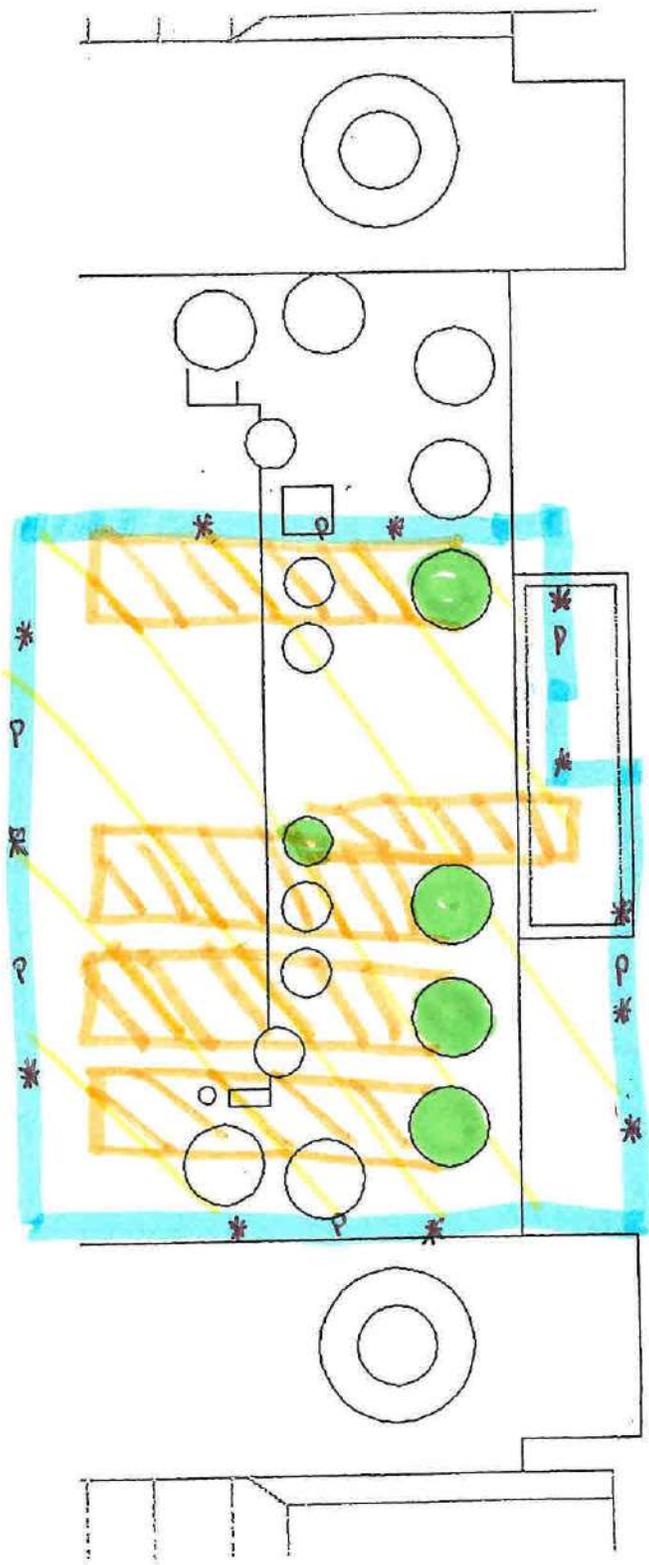
P = Particulate Monitoring
 * = Asbestos Monitoring

Trestle

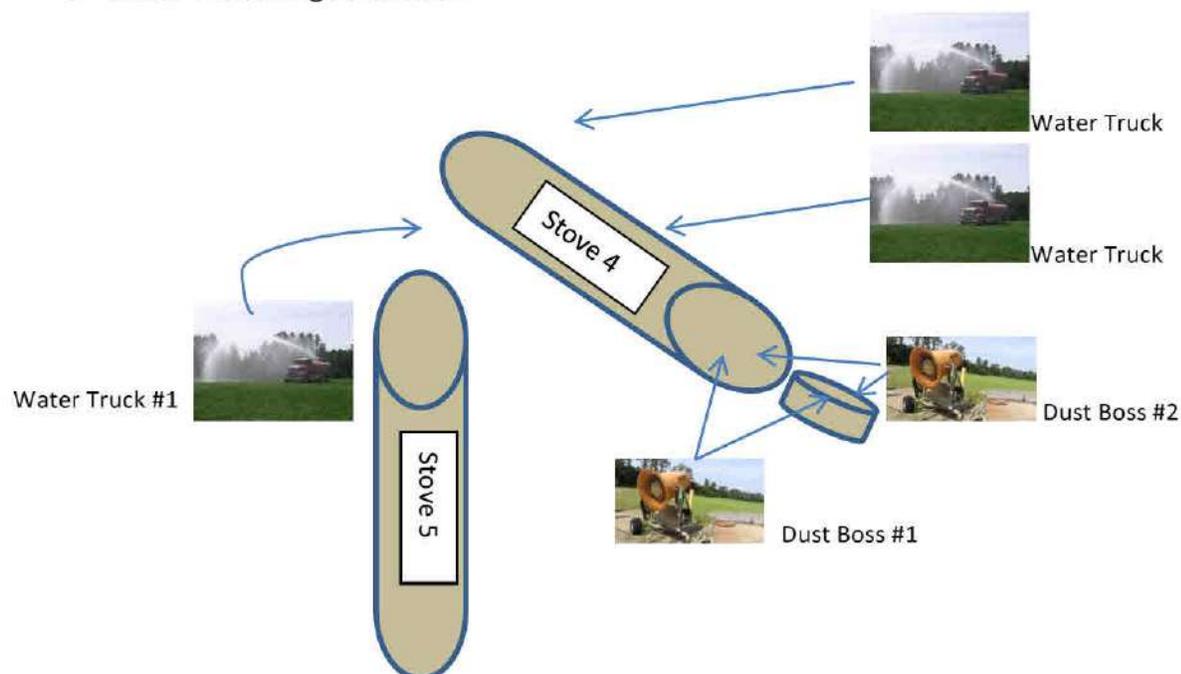
8. Water trucks will begin spraying when excavator operator takes slack out of cable and begins pulling stove.
9. Stove 4 watering schematic:

The following changes have been made prior to tipping stove 4, based upon a critical review of the stove tipping process observed during stoves 1 and 5. All changes made are in an effort to further mitigate dust during the process.

1. Increase interior wetting of stoves by adding fittings to both sides of the dome of each stove. Double water injection from 4,000 to 8,000 gallons of water pumped into the dome prior to commencement of the stove tipping process (amendment to item 9 of ETC recommendations).

4. Exclusion zone will be extended from 150' to 200' (amendment to item 11 of ETC recommendations).
5. Position water trucks and dust bosses based on wind direction (amendment to item 13 of ETC recommendations).

6. Decrease opening to 50%, from 60%. Increase rear sticker size to 24" from 12".
7. Once opening is complete and prior to final torch cutting, conduct a coordination meeting with all stove tipping operation parties. Make final adjustments based on wind direction and speed.

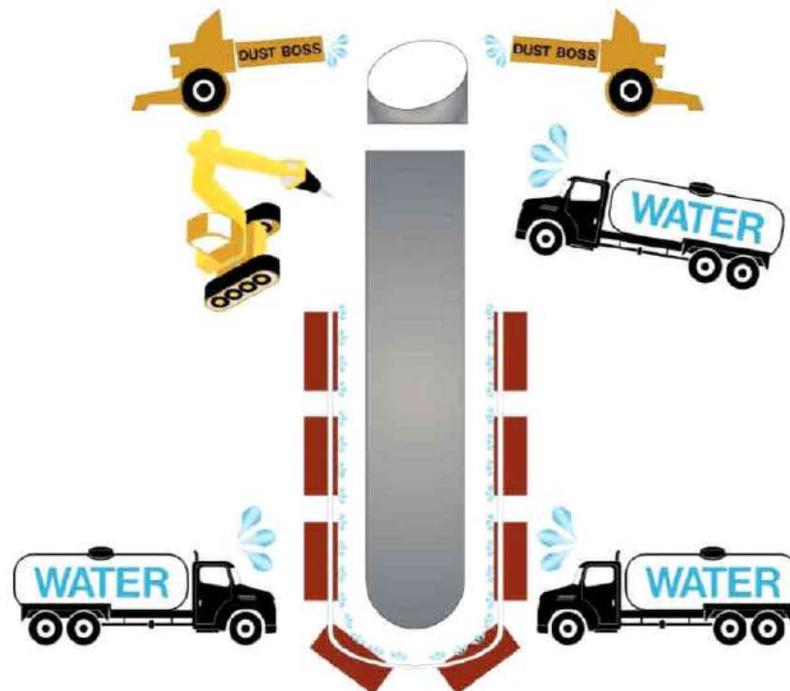
- a. The sea containers (8) will be placed in a horseshoe arrangement from the midpoint up and over the dome and back to the midpoint
 - b. Plywood, or similar material, will be used to close gap between sea containers

3. Water will be charged during final cutting and remain running until stove is down and dust has been completely suppressed.
4. Schematic:

STOVE TIPPING PLAN AMENDMENT 2 – ADDITIONAL MEASURES FOR STOVES 2 & 3

The following changes have been made prior to tipping stoves 2 and 3 based on a critical review of the stove tipping process observed during stove 4. All changes made are in an effort to further mitigate dust during the process.

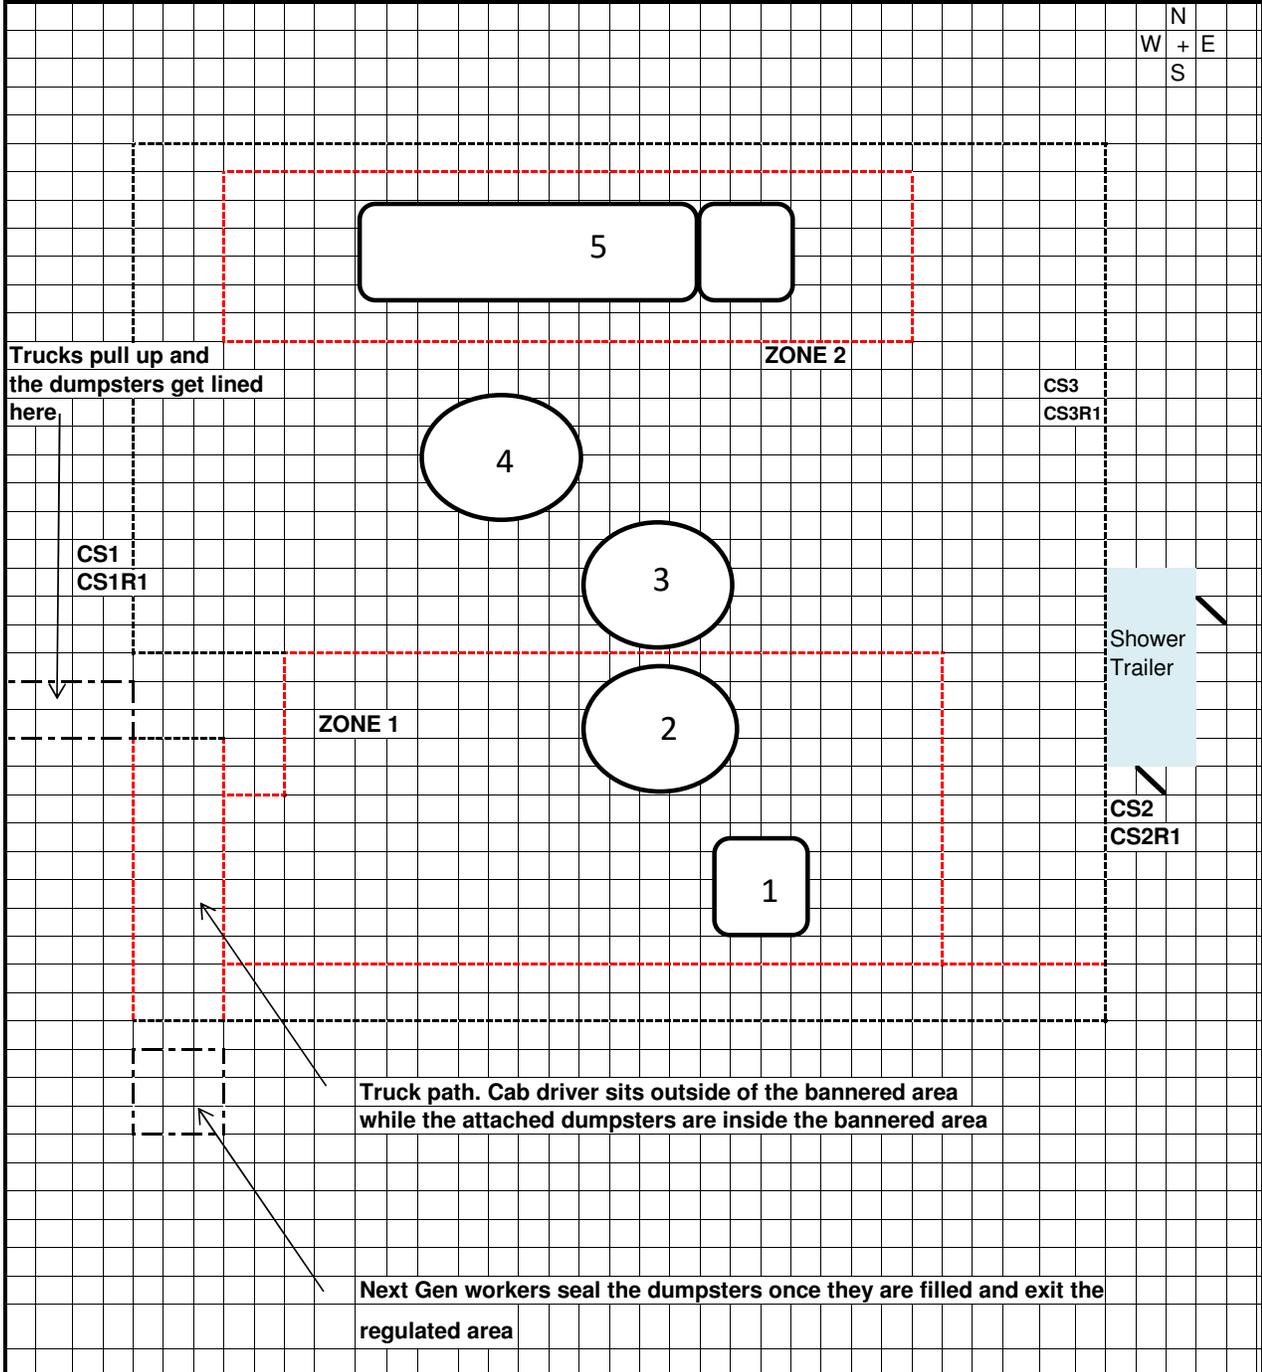
General Diagram of Work Areas

Client: Next Generation Environmental, Inc
 Contractor: Next Generation Environmental, Inc
 Facility: 1491 West Jefferson, Trenton, MI 48183
 Competent Person: Allen Offenbecker
 ETC Project #: 225924
 Date: 10/24/2019
 Hygienist: Randy Keathley
 Areas of Work: Area 4, Area 13, Area 14

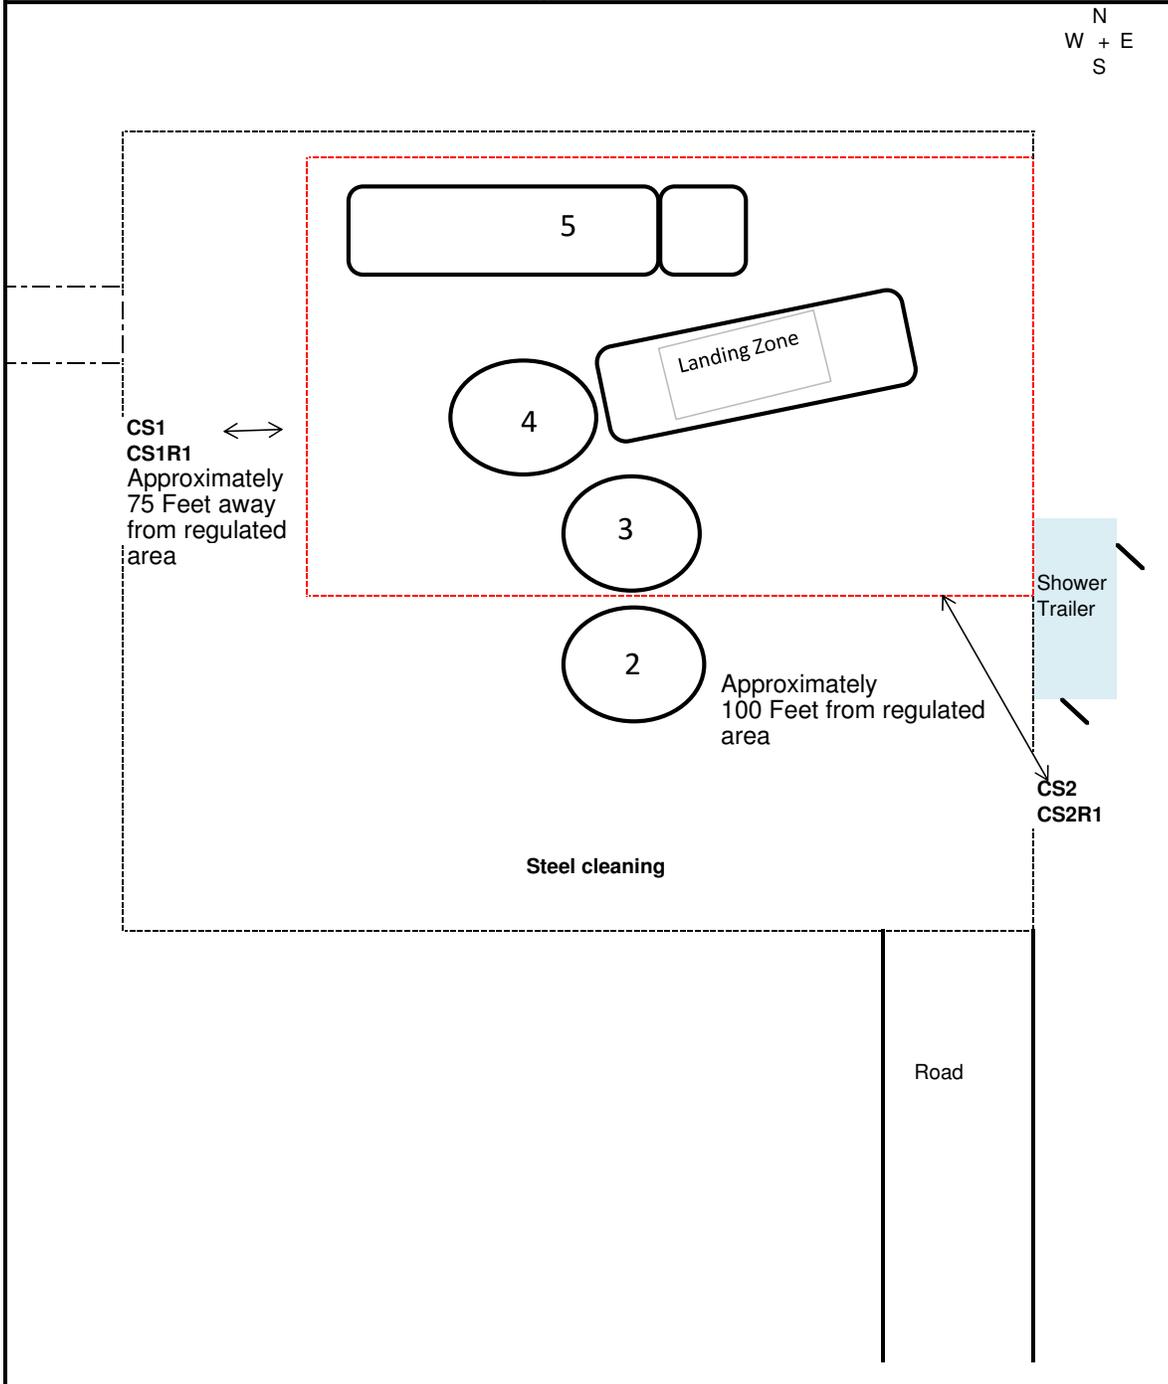
General Diagram of Work Areas

Client: Next Generation Environmental, Inc
Contractor: Next Generation Environmental, Inc
Facility: 1491 West Jefferson, Trenton, MI 48183
Competent Person: Allen Offenbecker
ETC Project #: 226942
Date: 11/6/2019
Hygienist: Randy Keathley
Areas of Work: Area 4, Area 13, Area 14

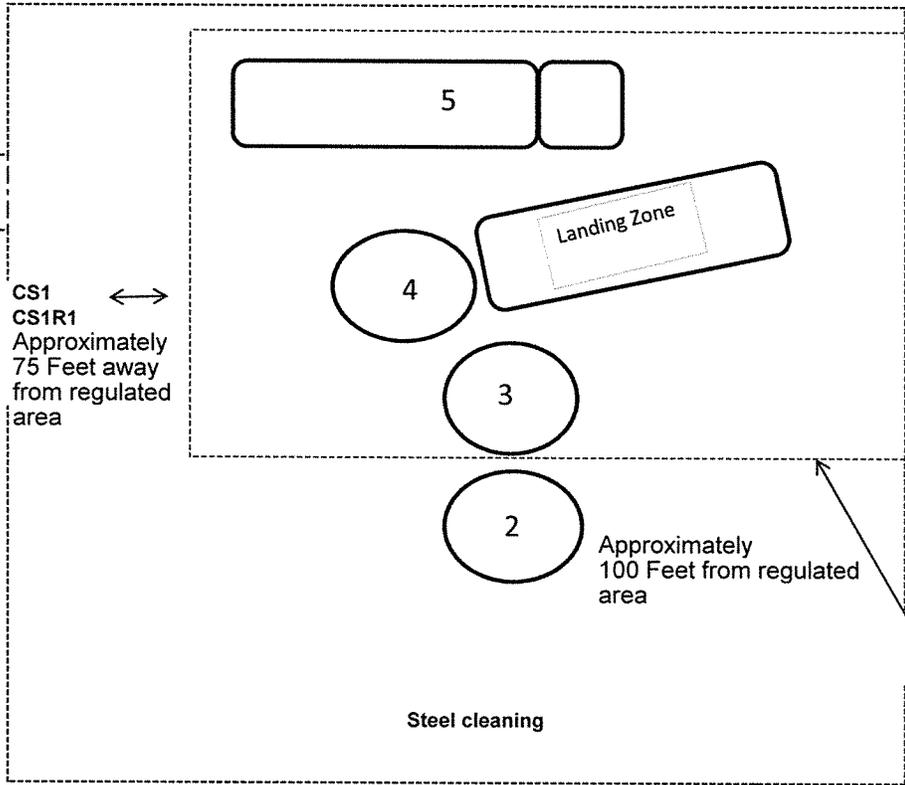
General Diagram of Work Areas

CS1
CS1R1
Approximately
75 Feet away
from regulated
area
